The Starvation of Southold's Beaches

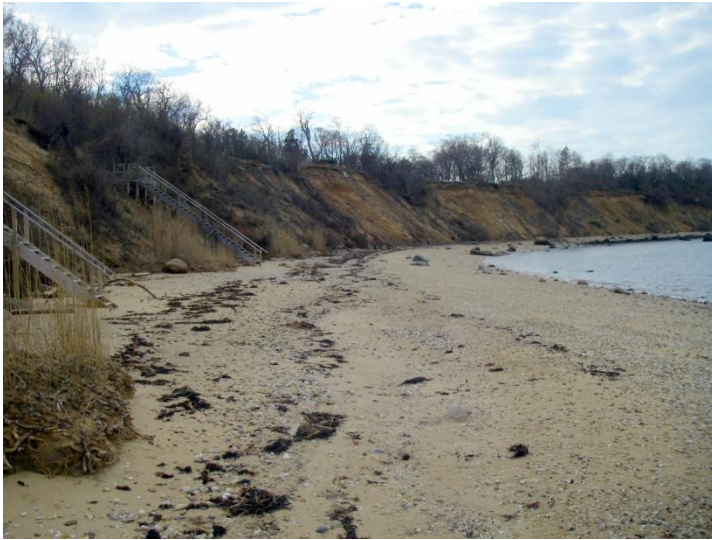
Figure 1. Unhardened but eroding bluffs such as those here between Town Beach and Horton Point supply sediment to support a natural, wide beach. 12/01/2014.

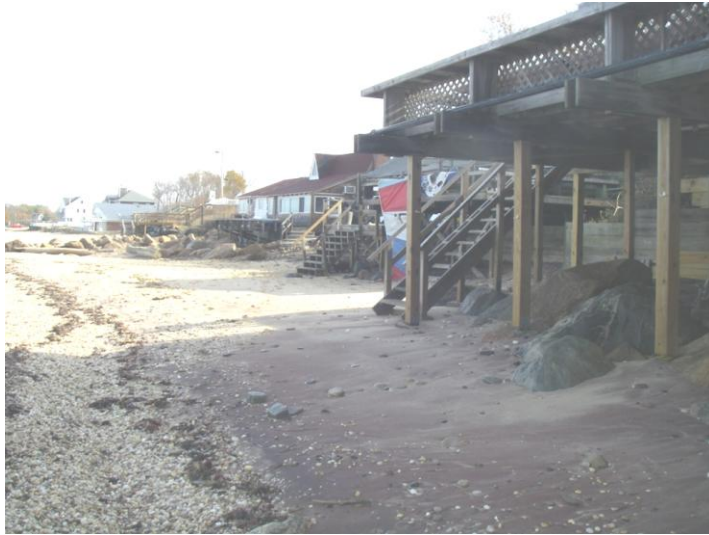
On this walk, one first encounters a row of houses set low on a beach that already suffer the ravages of storm surges, as evident by wood boards and boulders assembled for protection from flooding (Figure 2.). This flooding is the result of the beach being lowered over the past few decades because of insufficient sediment replenishment. The lowering of these beaches is not unknown to Southold Town, which regularly renourishes Town Beach with sediment to protect the beach and adjoining parking lot from storm washouts.

Figure 2. Soundview Avenue, Southold, west of town beach. Groins and bulkheads to the west inhibit the supply of sand with the result that the beach is lowered, allowing storm surges to attack residences.
11/12/2014

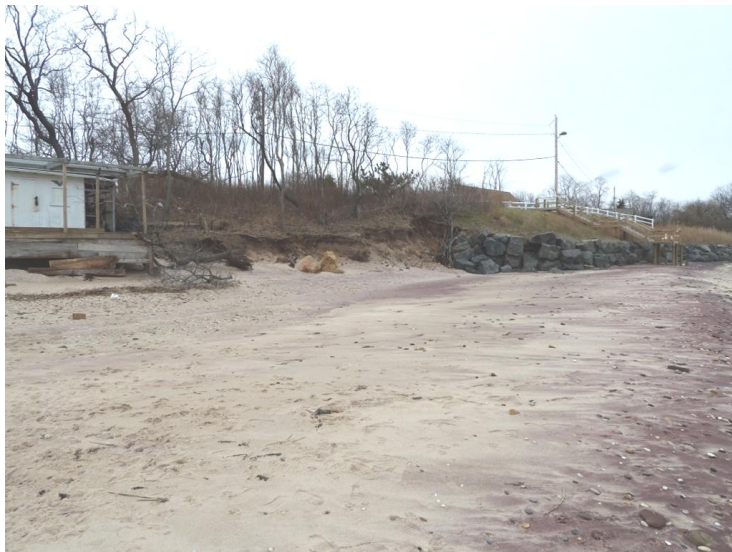
Proceeding west, one encounters a town-built revetment on private property (Figure 3), paid for by town taxpayers, to prevent Soundview Avenue from being washed away. The property owner thanks the taxpayers by posting “Private No Trespassing” signs. This town-built revetment has facilitated a serious blowout of the unprotected bluff immediately to the east with the result that the bluff line has retreated 10 to 12 feet landward from the revetment toe since the revetment was built in 2012.

Figure 3. Soundview Avenue. An unprotected bluff blowout occurs at the east edge of a town-built revetment because the revetment is more resistant to erosion but is subject to being outflanked by erosion from the side.
12/26/2012 []

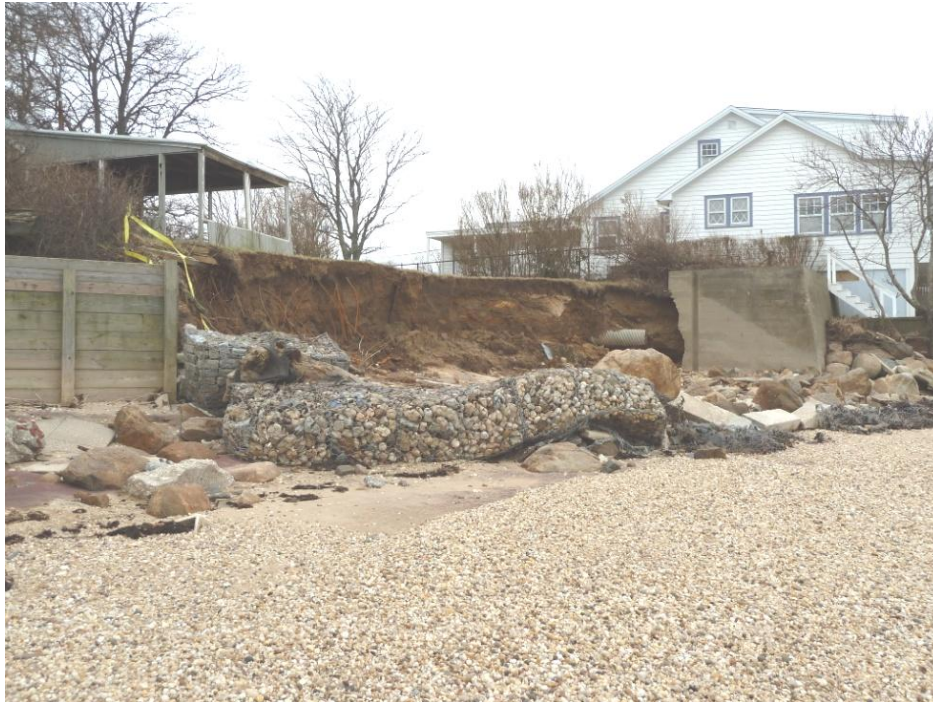
As shown in Figure 4, we have a sharp right angle boundary between an unprotected bluff and a 9+ ft. high vertical concrete, return seawall which extends seaward perpendicular to the beach. At the right angle corner where the bluff and seawall connect, erosion is intensified and is now cutting back behind the seawall to threaten the integrity not only of the seawall but also of the foundation of the seawalled residence it was built to protect.

Figure 4. 21815 Soundview Avenue. Bluff blowout adjacent to a seawalled property that itself is threatened as erosion cuts back to outflank the seawalled property's foundation and also undermine a neighbor's unprotected residence. Notice the wired gabion placed to protect the bluff has been tossed aside by wave action. 11/12/2014

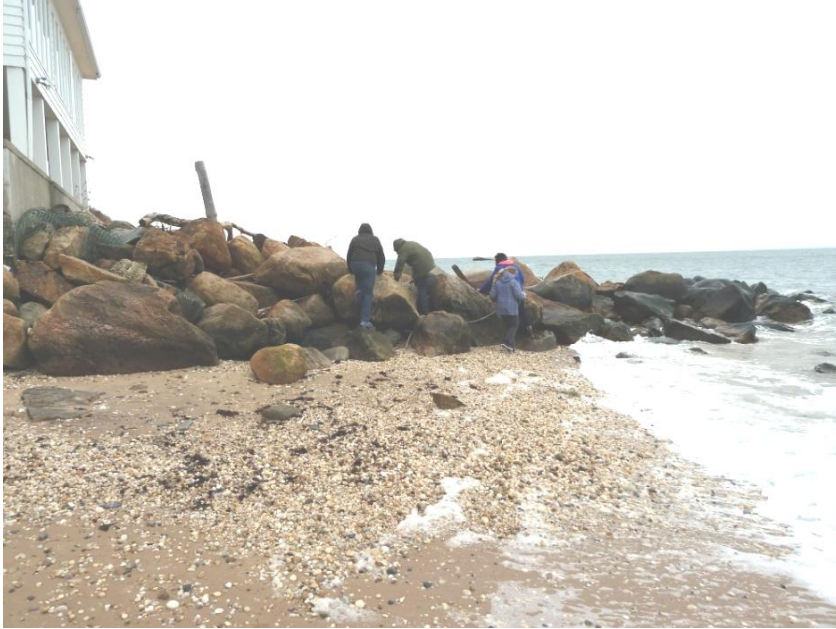
One next encounters two boulder groins, the second of which is unsafe for normal foot passage.

Figure 5. 21815 Soundview Avenue. Boulder groin blocks safe public passage along the beach, which is a violation of the public's right of lateral access. 12/26/2012

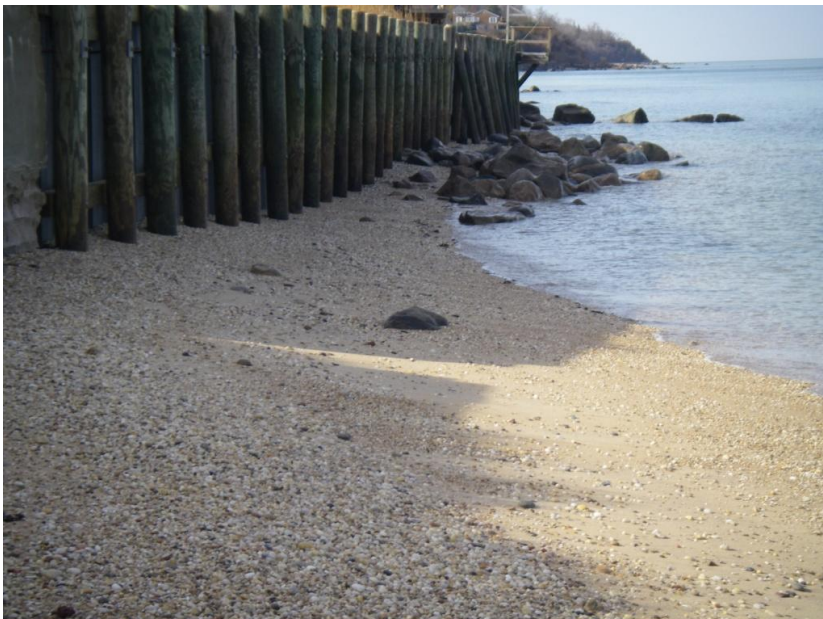
One practice the Trustees currently follow to address bluff erosion is to approve applications for toe armoring, by which boulders are placed at the foot of bluffs in an attempt to impede the scouring actions of storm waves. Evidence does not support that this is an effective solution in all situations (Figure 6.).

If one manages to safely negotiate this boulder groin, one encounters a formidable wall of bulkheads that stretch uninterrupted into the distance (Figure 6).

Figure 6. Soundview Avenue. Low Tide. Wave scour against bulkheads causes the beach to disappear, along with public access, because sediment is removed and not replenished. Notice toe armor has been scattered by wave action offering little protection for bulkheads, which calls into question the effectiveness of toe armor in all situations. 11/12/2014

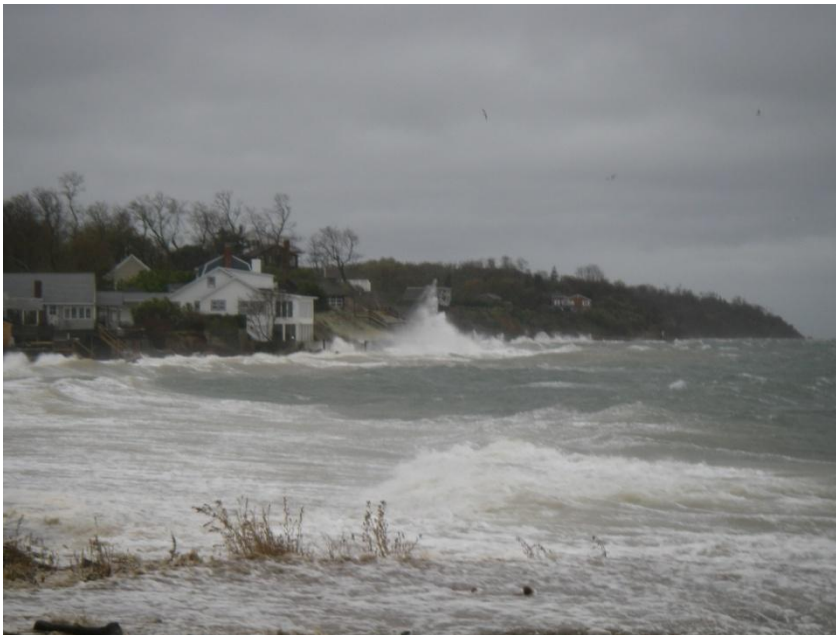
Such a long continuum of vertical bulkheads presents an unnatural face to confront the fury of gale-driven storm surges with wave energy reflected rather than absorbed as it would be on a gently sloping natural beach. Wave turbulence intensifies at the foot of the bulkhead, picking up loads of sediment to be carried away by the longshore current, which itself is now speeded up by absorbing the reflected wave energy. The power of the wave turbulence is more than enough to scatter poorly designed toe armour emplacements. Dramatically, the reflected waves mesh into the incoming storm waves to explode as vertical masses of sea spray that impact and erode the unprotected bluff above the bulkhead (figure 7.).

Figure 7. 21815 Soundview Avenue. Storm waves strike vertical bulkheads with explosive force jetting up massive and repetitive sea sprays that can be over 20 ft. in height and capable of attacking and eroding bluffs above bulkheads. 10/29/2012
